PIKE COUNTY, PENNSYLVANIA
PHASE II INSPECTION REPORT
NATIONAL DAM INSPECTION PROGRAM

PHASE I REPORT
NATIONAL DAM INSPECTION PROGRAM

Name of Dam: LOWER HEMLOCK DAM
State & State No.: PENNSYLVANIA, 52-117
County: PIKE
Stream: TRIBUTARY TO ROCK HILL CREEK
Date of Inspection: April 2, 1980

LOWER HEMLOCK DAM

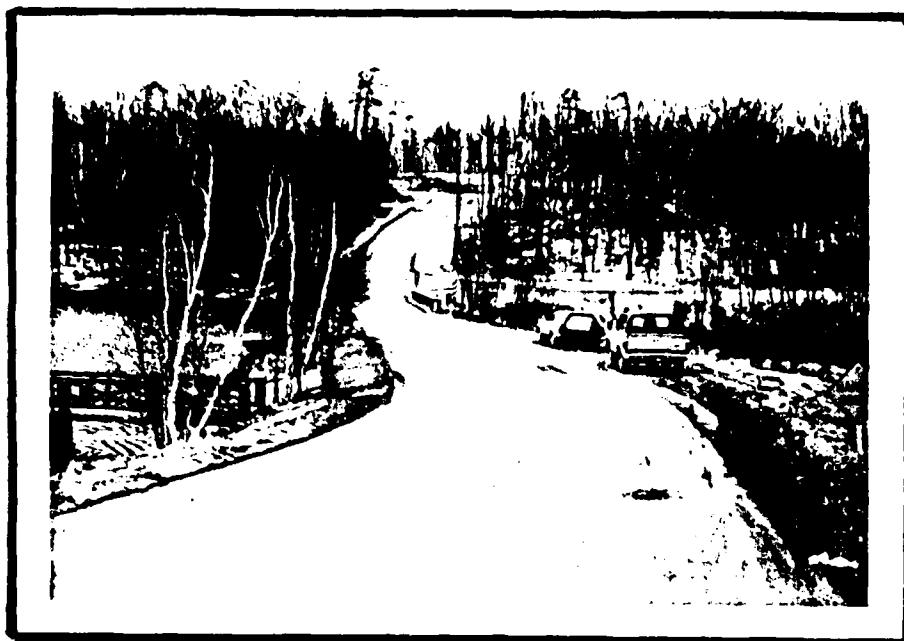
OVERVIEW FROM RIGHT ABUTMENT - NO. 2
